**Subject:** Boilers with new terminal box in cascade systems

**Models:** All boilers shipped before 7-15-14 with new style terminal boxes.

**Problem:** Communications wiring error

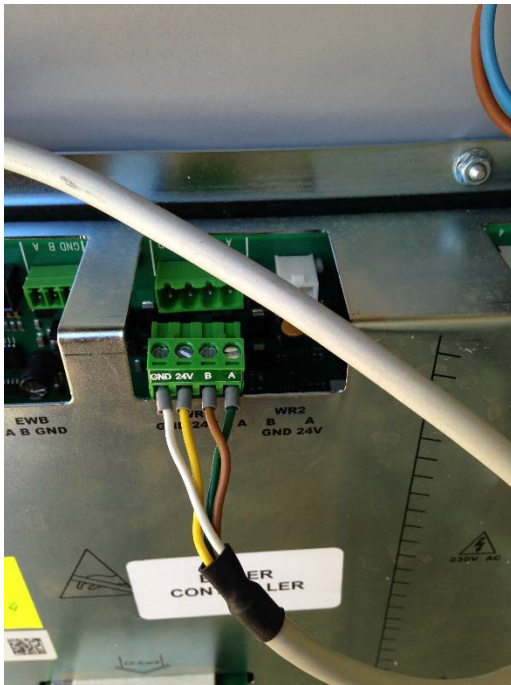
It has come to our attention that the communications wiring from the CMP to the new terminal box at the rear of the boilers has an error. This will only affect boilers using the Pelletronic I/O box or boilers set up in cascade. The solution to the communications error that will occur is to rewire the communications plug at the front of the CMP where it is plugged into the CMP itself. See picture attached for correct colors and connections. Left to right, correct colors are, white to the ground connection. Yellow to the 24 volt connection. Brown to the B connection, and green to the A connection.

**Caution!** Wiring should be done when boiler and I/O box are de-energized.
